**ASBESTOS MANAGEMENT SURVEY  
OF**

**Communal Areas  
5 – 11 Kimball Close  
Langham  
Oakham  
Rutland  
LE15 7QP**

**Project No.: MGE-18016**

**Survey Date: 02<sup>nd</sup> February 2018**

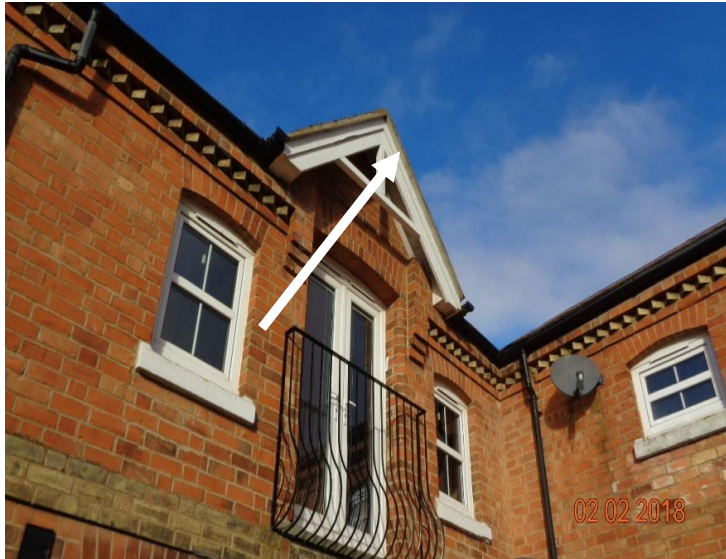
Sample No.	Photo No.
MGE/PAC001	01

- 1.3. **The following ACMs have been identified within the scope of this survey.**
  - External – Cement Undercloaking Above Juliet Balcony – Presumed Asbestos Content (Sample MGEpac/001)

Sample No.	Photo No.	Floor	Location/ Sample Description	Material Assessment (MA)				MA	Extent	Accessibility	Recommended Actions	Next Inspection	Inspection comments
				Product Type	Asbestos Type	Extent of Damage	Surface Treatment	Score					
MGE/ PAC001	01	Ext.	External, Cement Undercloaking	AC	Presumed	Low	Unsealed	LOW	2. 1m	Low	Manage	02/02/2019	
				1	3	1	1	6

Manage. Work with asbestos cement products does not require an HSE licence. However, all work with asbestos containing materials should be carried out in accordance with the Control of Asbestos Regulations 2012. Disposal of all asbestos containing waste materials should be carried out in accordance with the Hazardous Waste Regulations 2005.
